Detailed investigation of fracturing at the boundary of rock salt and anhydrite using engineering geology methods and ultrasonic measurements

Daniela Budzinski, Thomas Spies, Hans-Joachim Alheid (Hannover) & Jürgen Eisenblätter (Ober-Mörlen)

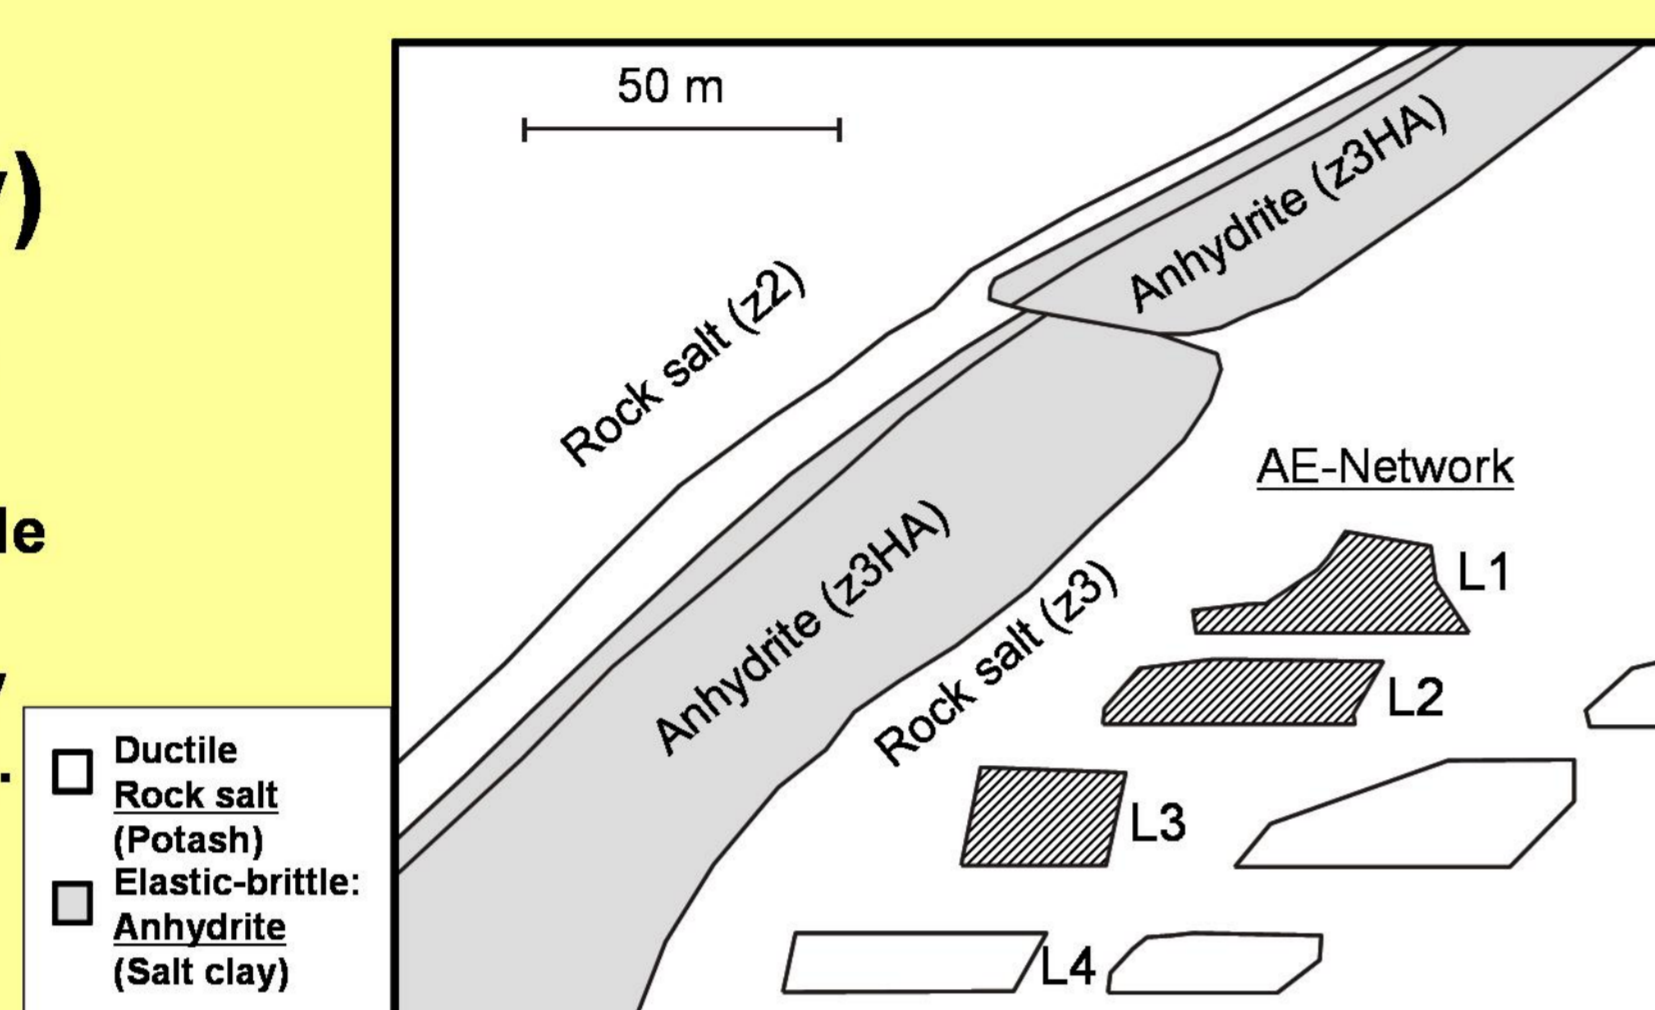
Sketch of geology (Zechstein NW Germany)

- AE network of 24 sensors at Levels L1 to L3 (depth -280 m NN to -305 m NN).
- Boundary of ductile rock salt and brittle anhydrite near cavities.
- Stress concentrations at the boundary can cause micro- and macrofracturing.

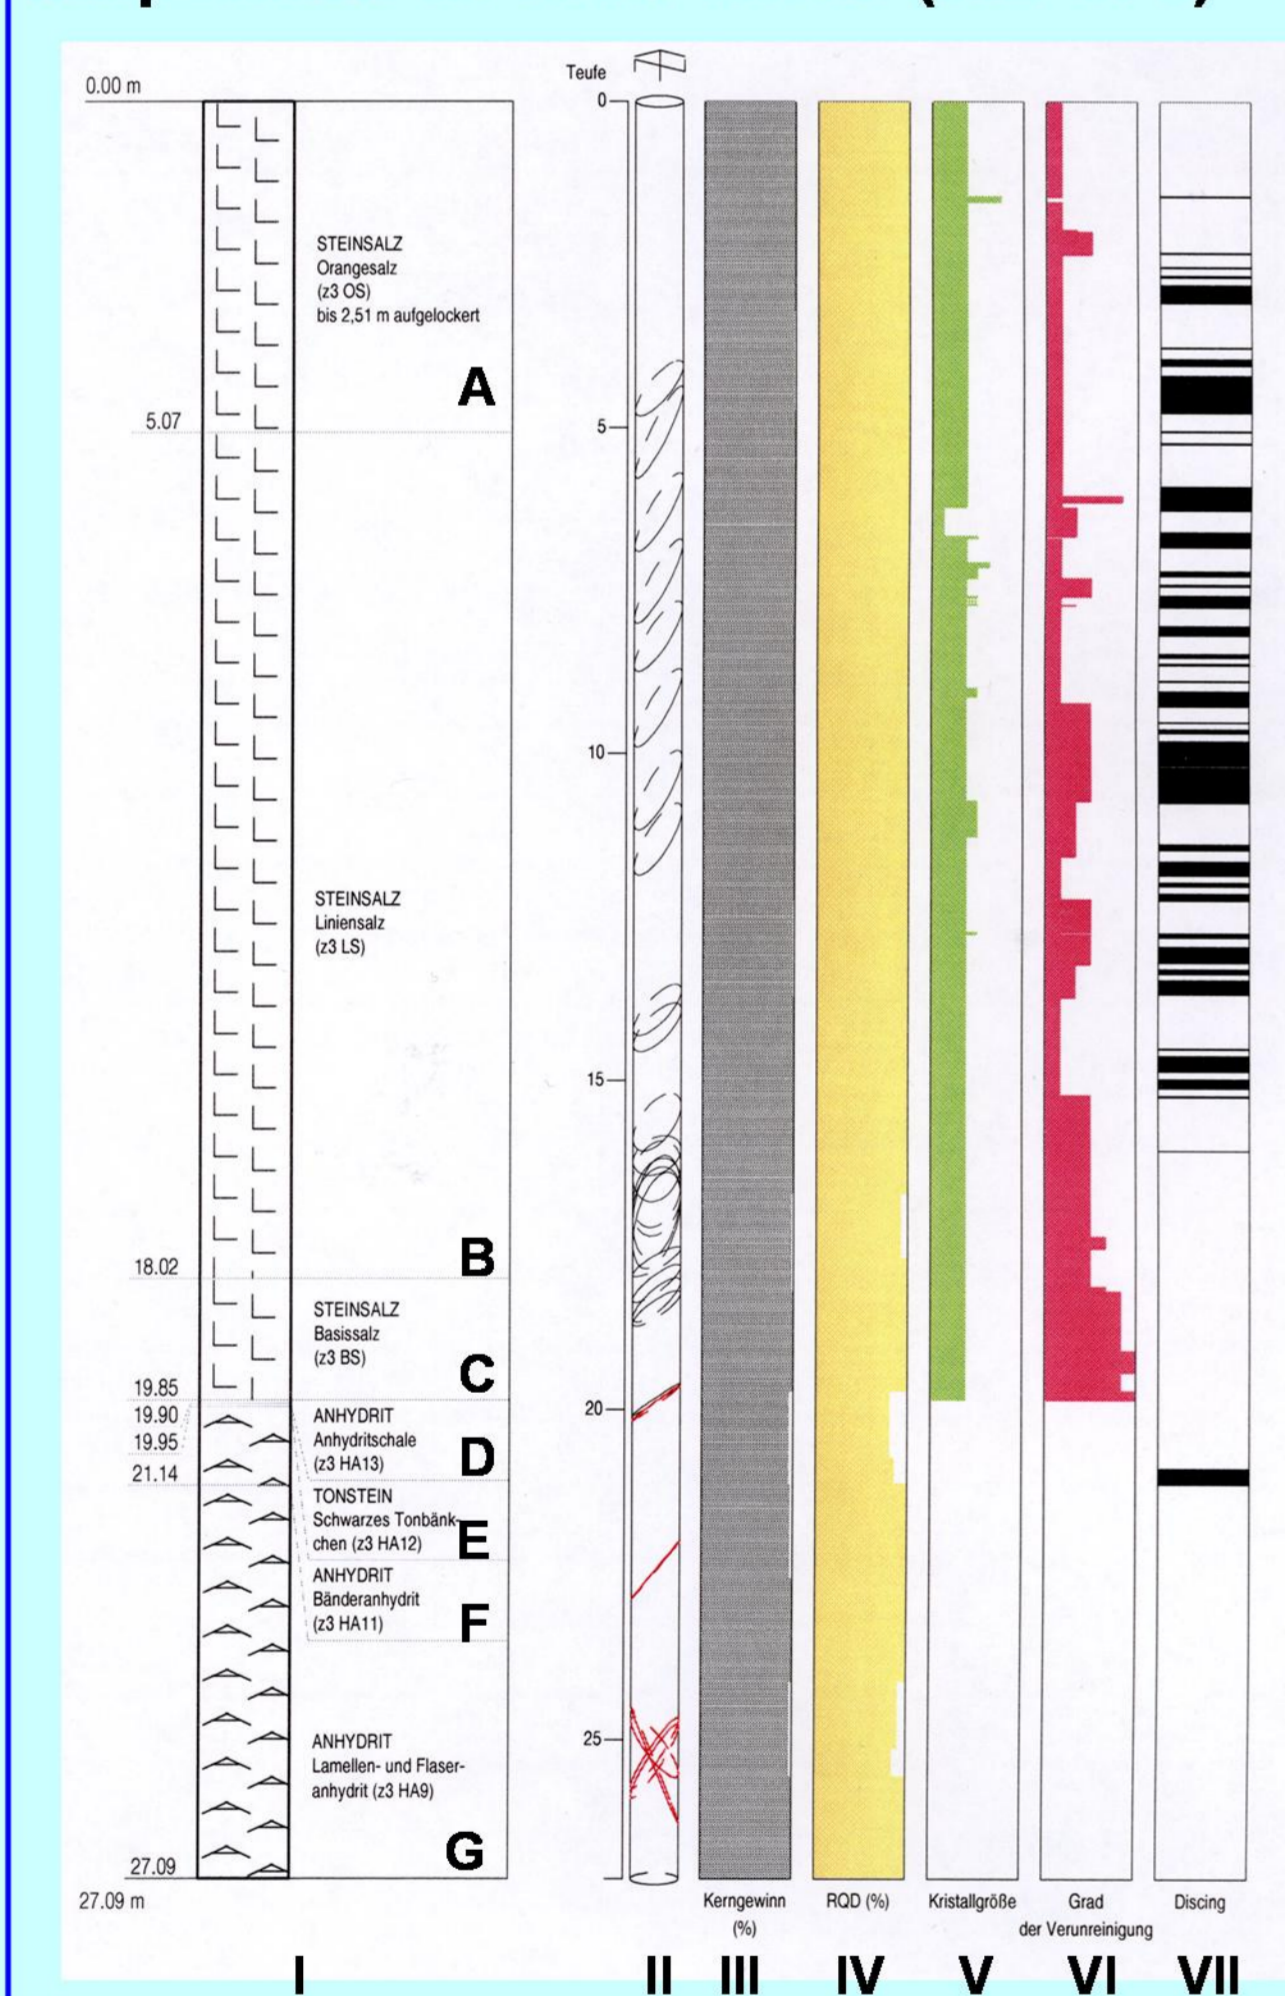
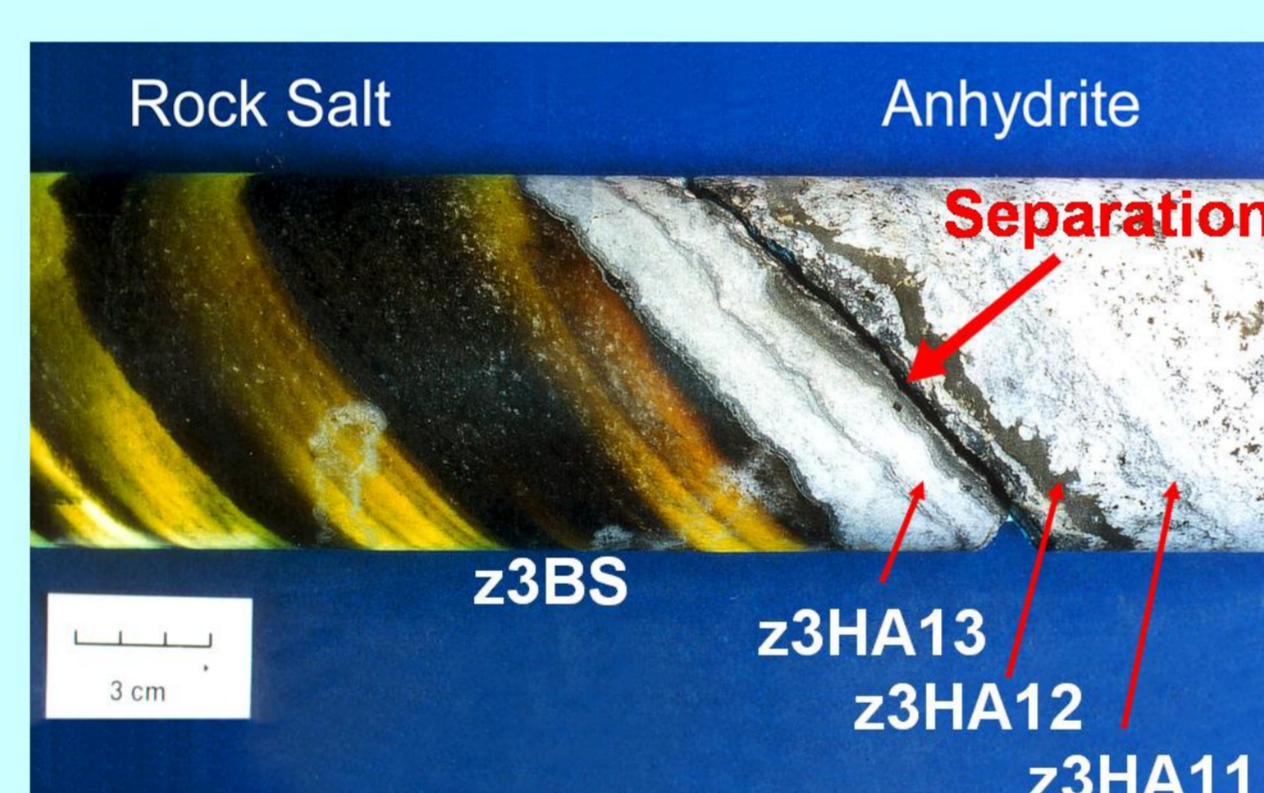
Inspection of rock cores (RB 971)

Near boundary rock salt – anhydrite: separation of core in thin layer of clay.

- I: Lithology:
 A: Rock salt z3OS (EDZ up to 2.5 m)
 B: Rock salt z3 LS
 C: Rock salt z3 BS
 D: Anhydrite z3HA13
 E: Clay z3HA12
 F: Anhydrite z3HA11
 G: Anhydrite z3HA9
- II: Bedding (black), separation of cores (red)
 III: Amount of gain
 IV: Rock Quality Designation (RQD)
 V: Size of rock salt grains (4 classes)
 VI: Impurities in rock salt (3 classes)
 VII: Discing

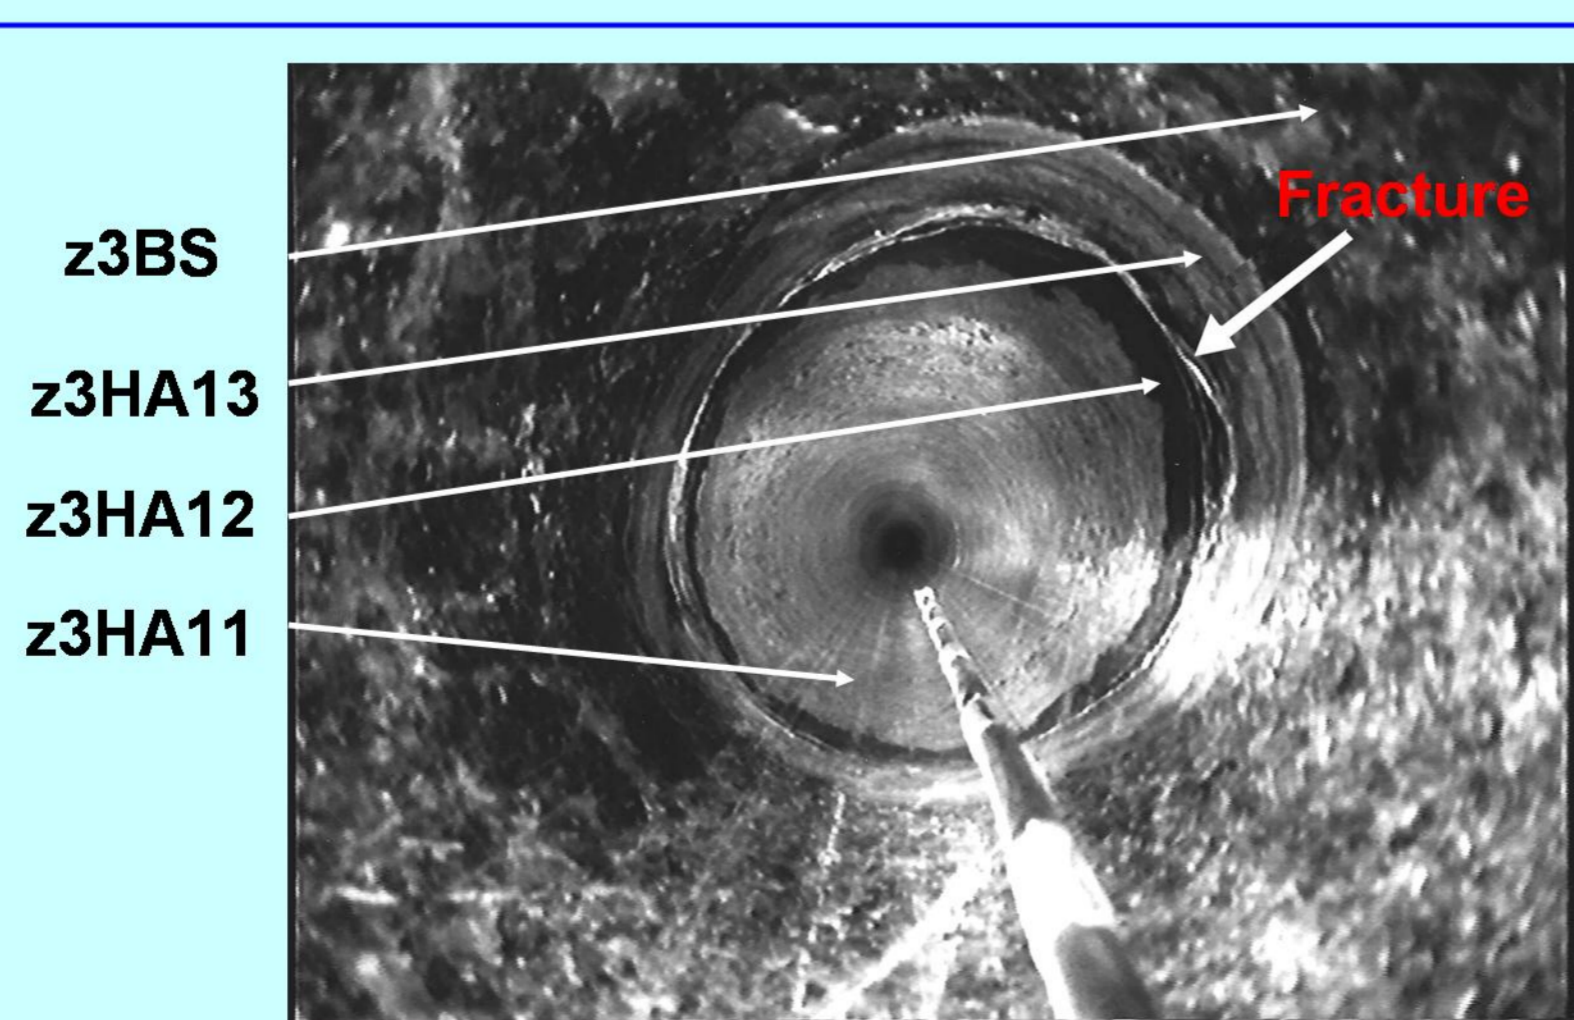
Inspection of borehole walls using a video camera

Wide angle view of the boundary of rock salt and anhydrite with identification of a fracture directly behind the boundary (whitish line).

In anhydrite section of borehole 3 fractures were identified in RB971 and 5 in RB972.

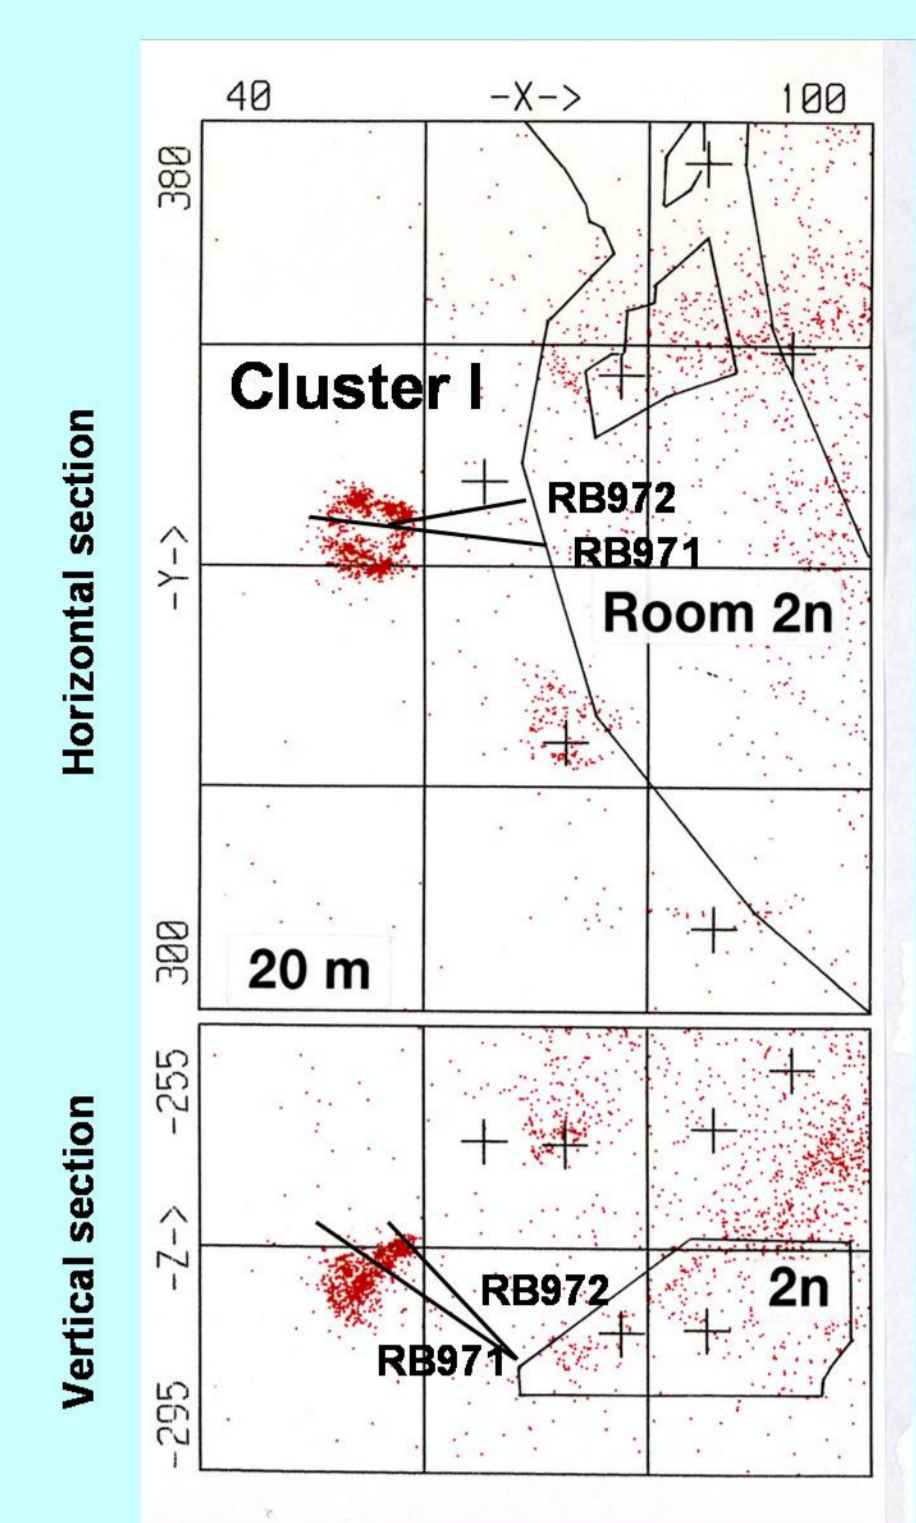
Location of AE events (right figure):

- Data from Jan 97 to Jun 97: Cluster I activity emerged during 2 days near Room 2n.
- Verification of AE results by drilling of two boreholes in center of ring-shaped structure (RB971) and in outer part (RB972).

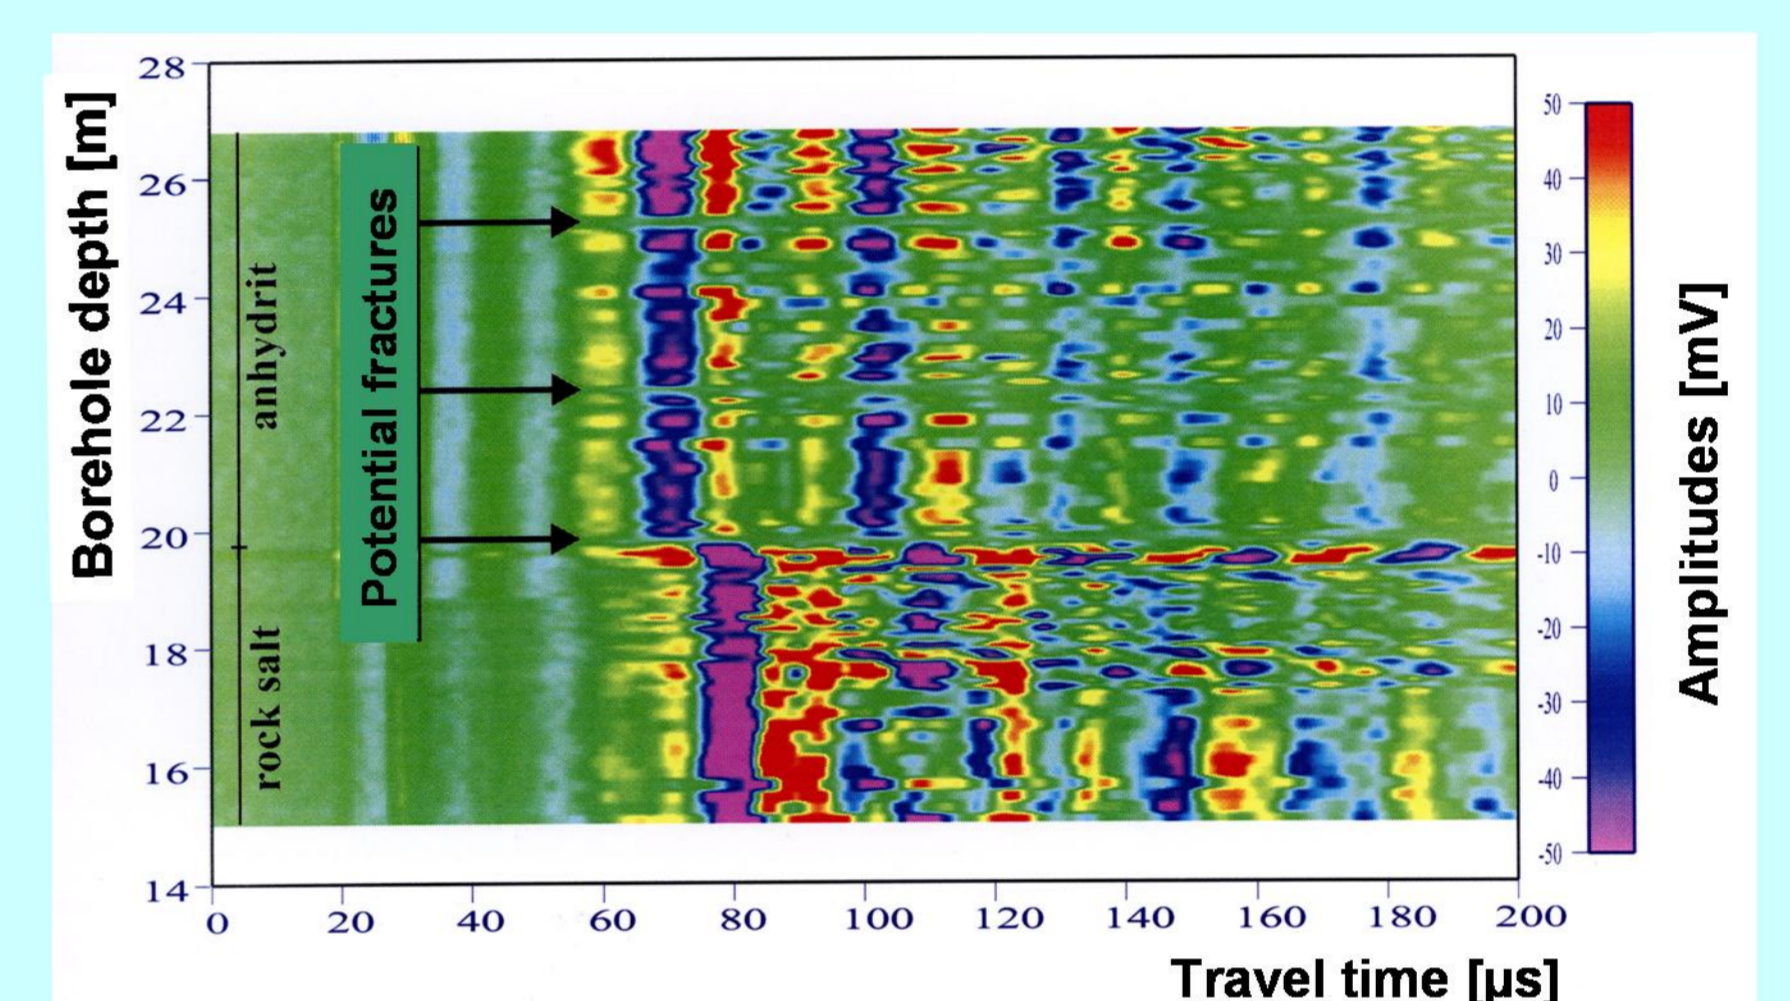
Interval measurements along borehole RB971: Color-coded seismogram section

- Lower part: signals in rock salt.
- Upper part: signals in anhydrite with 3 potential fractures indicated by low signal amplitudes in RB971.
- Potential fracture directly behind boundary of rock salt and anhydrite.

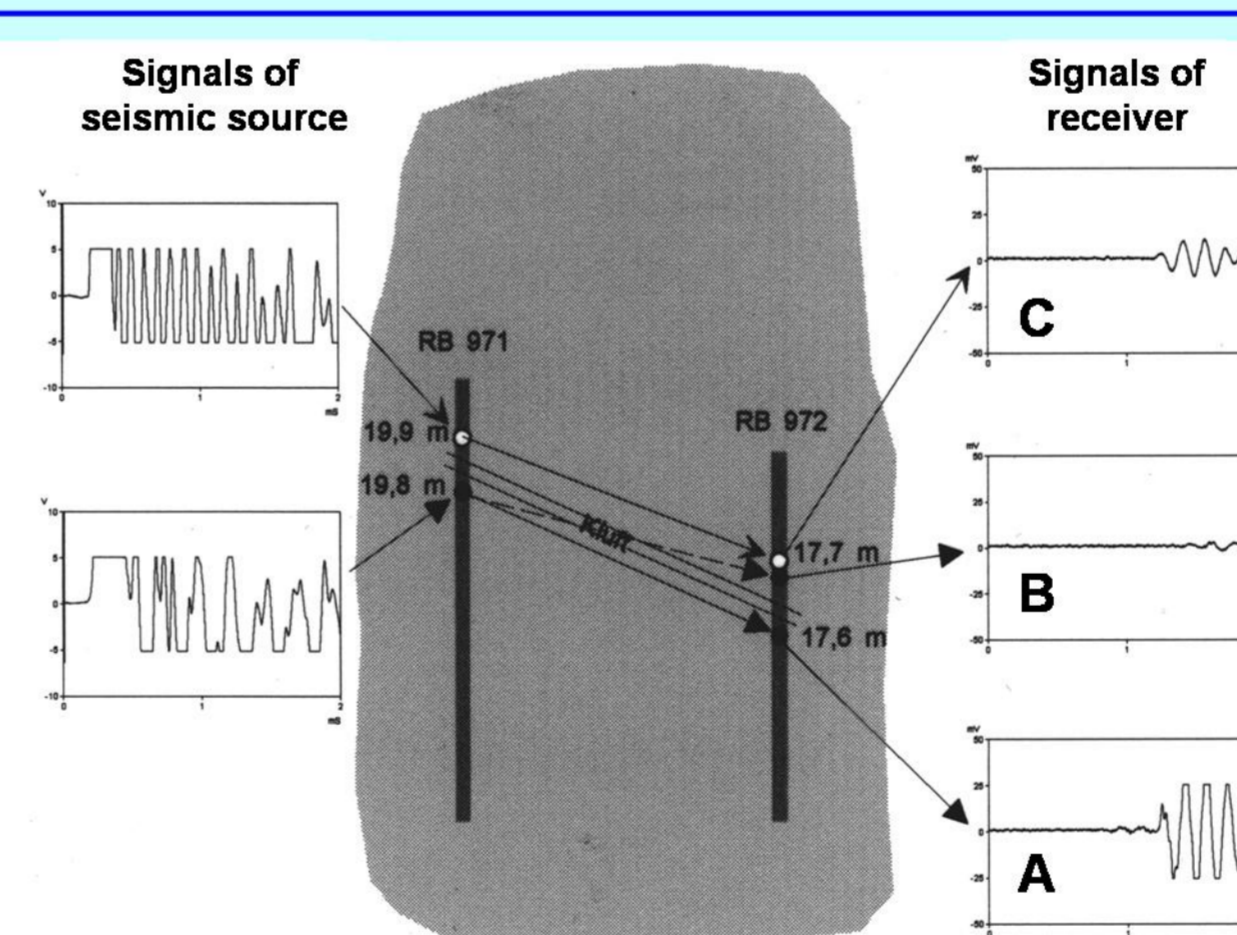
Crosshole measurements at boundary of rock salt and anhydrite

- Large signal amplitudes when seismic source and receiver both were located before fracture and behind fracture (see signals A and C in right part of figure).
- No signal detected when source was before fracture and receiver behind (see signal B).
- Conclusion: Fracture behind boundary is persistent between boreholes.

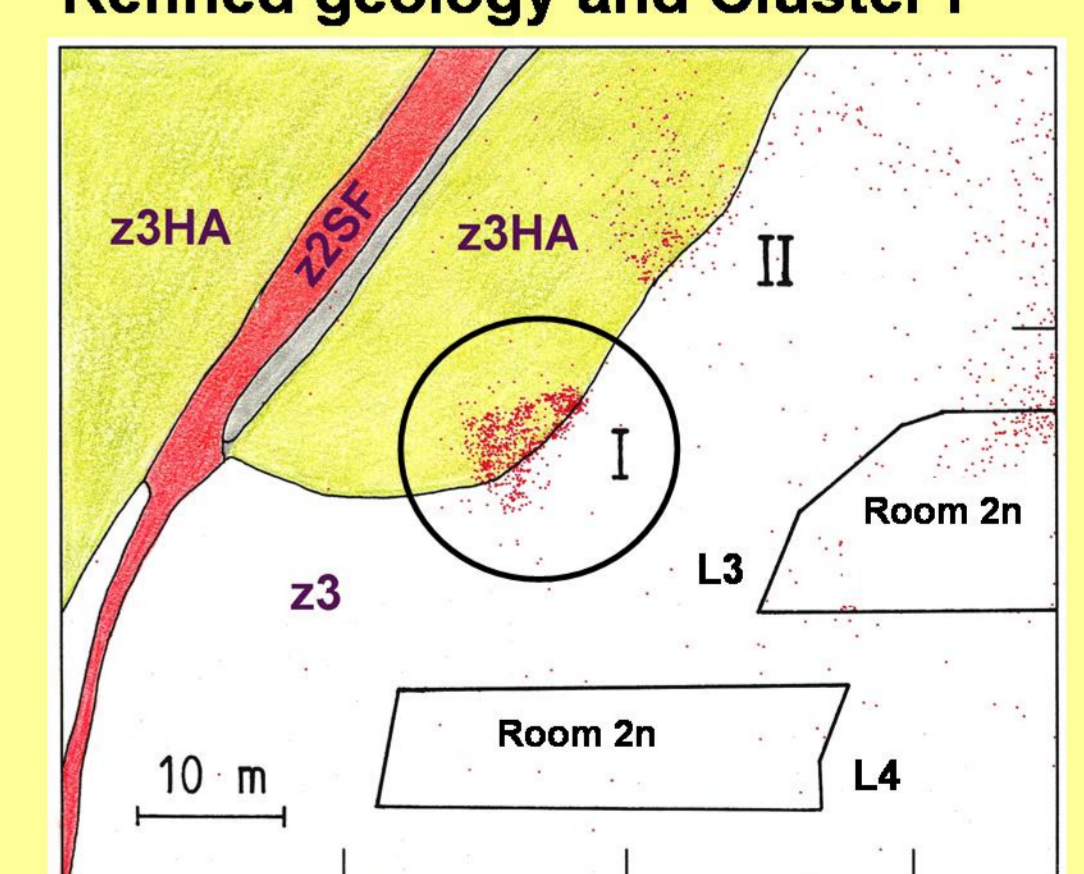
Refined geology and Cluster I

The cluster of AE events emerged at the boundary of rock salt and anhydrite. The refined geology is displayed in a vertical section in the lower figure with the cluster, here called No. I. A fracture was found in a thin clay layer at the boundary being a zone of weakness. The AE events of the cluster marked the growth of the fracture zone of about 8 m diameter.
