Detailed investigation of fracturing at the boundary of rock salt and anhydrite using engineering geology methods and ultrasonic measurements

Daniela Budzinski, Thomas Spies, Hans-Joachim Alheid (Hannover) & Jürgen Eisenblätter (Ober-Mörlen)

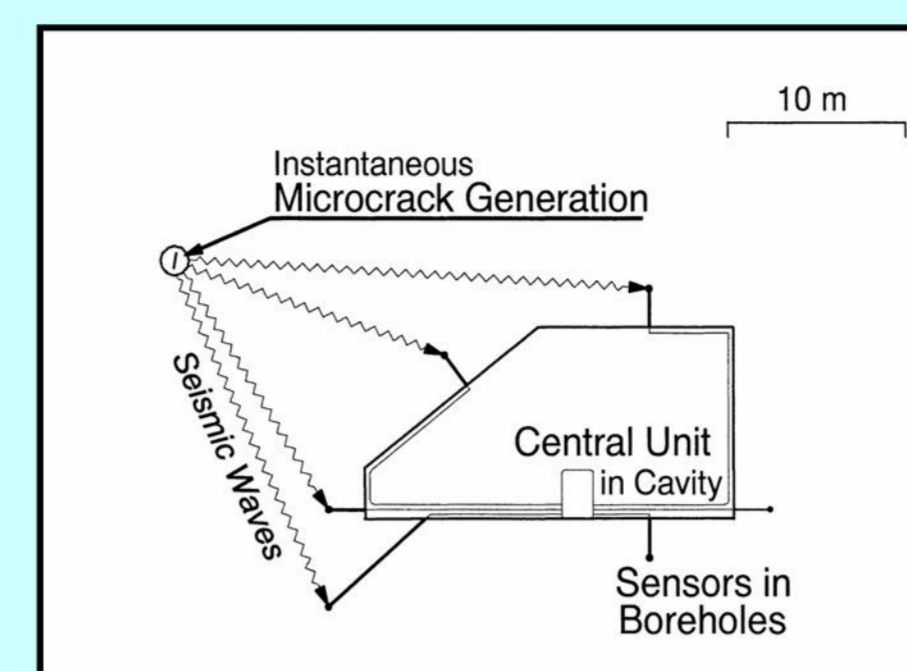
Principle of measurements

Location of AE events (right figure):

- Data from Jan 97 to Jun 97: Cluster I activity emerged during 2 days near Room 2n.
- Verification of AE results by drilling of two boreholes in center of ring-shaped structure (RB971) and in outer part (RB972).

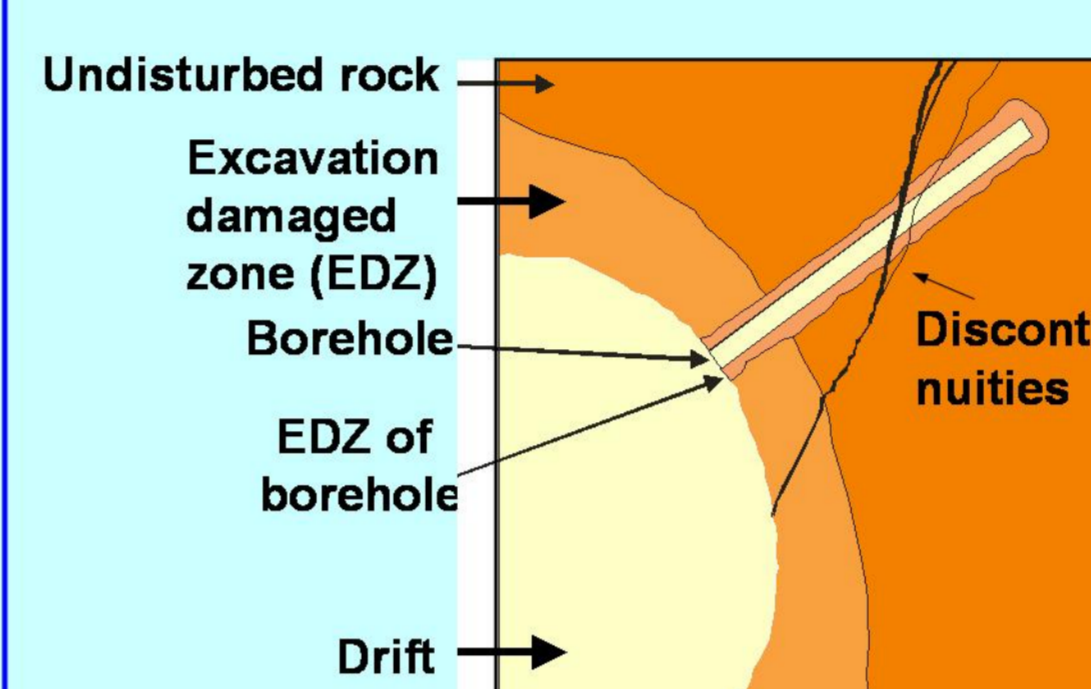
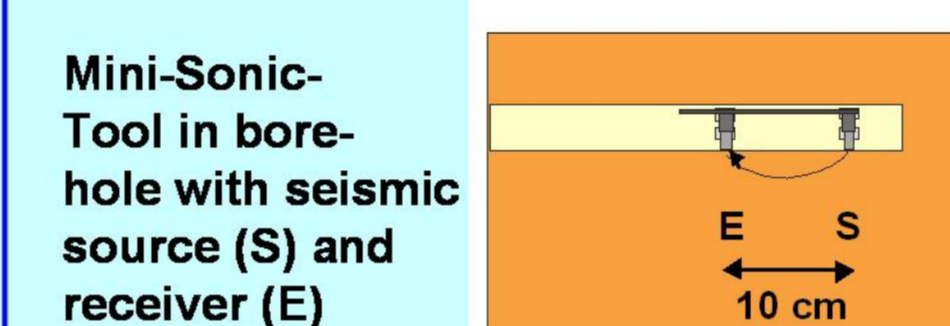
Principle of measurements

- Interval measurements in one borehole by movement of one tool along borehole.
- Crosshole measurements between two boreholes by movement of two tools.
